# Failure Analysis of Reverse-Gearbox Components for RL 15 Motorized Railway Trolley

## ABSTRACT

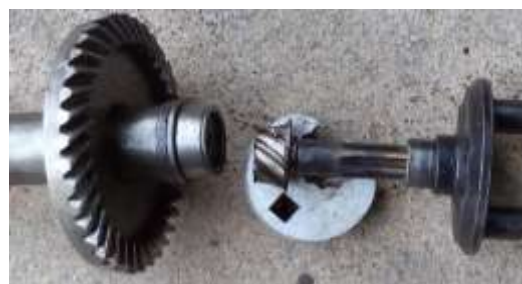
A careful examination of 6 Nos. of the failed motorize rail trolleys in Bauchi, Zaria and Kafanchan railway workshops revealed that the frequent reverse-gearbox failure poses a challenge to operational life of the trolleys, and hence raising very pertinent durability concerns, and bringing to question the material integrity of the selected gearbox components. From visual inspections, the

Figure 3: Failed components (from L-R): Ring gear and shaft, pinion, coupling, and rubber-damper

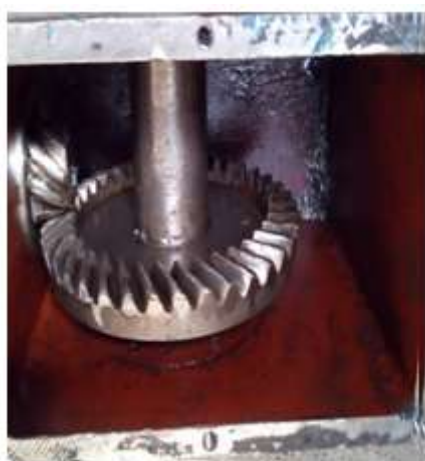
Plate 4: Interior view of Reverse-gearbox assembly consisting of pinion, ring gear and shaft

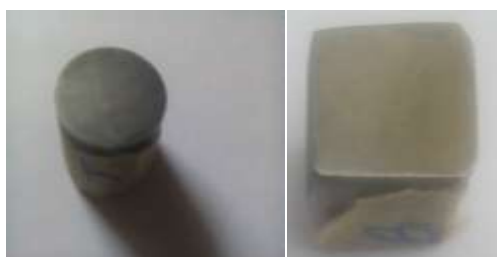
Plate 5: Sample A (i.e. failed Pinion) Plate 6: Sample B (i.e. failed Ring Gear)

From Table 1, the surface hardness of the sample A (pinion) is 42.83 HRC and sample B (ring gear) is 44.73 HRC. The results show that sample B possess a harder surface hardness than sample A. The differential surface hardness between sample A and sample B surfaces is likely to equalize the rate of wear. However, sample A is expected to harder than sample B because sample A, as the pinion, does more work per tooth than sample B, the ring gear, owing to the fact that the pinion has lesser number of teeth than the ring gear. Harder pinion teeth will help to correct the errors in the gear to an extent, and increase its ability to withstand wear due to its higher hardness number attributed to the cold-worked surface [9].

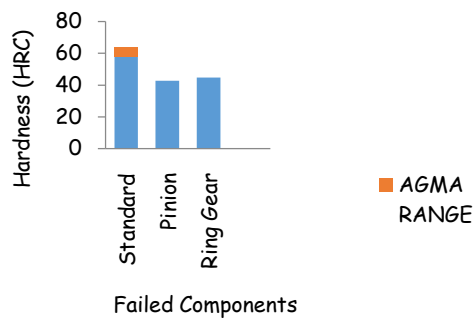
Figure 1 compares the hardness of the pinion and the ring gear to the recommended American Gear Manufacturing Association (AGMA) standard for gear teeth surface hardness. Thus, both the pinion and the ring gear surface hardness were found to be lower than the recommended AGMA standards; as the minimum surface hardness for gears [10]. Hence, it is recommended that the material be case-hardened to further increase its hardness property durability.

Figure 1: Bar chart comparing AGMA standard with failed pinion and ring gear surface hardness
