Physical and Mineralogical Study of Bricks of Historical Masonry Structures of Bhopal, India.

ABSTRACT:The present study is based on the physical, mechanical and chemical-mineralogical characterization of more than two and half century-old brick samples collected from Bhopal City of Central India, using mechanical, Field Emission Scanning Electron Microscope (FESEM)Energy-dispersive X-ray spectroscopy (EDX), and X-ray powder diffraction (XRD) techniques. In all three types of clay brick samples used in this study, the mineralogical phases existed were quartz, Muscovite and feldspars majorly. These bricks were compared with the sample of present day modern samples.

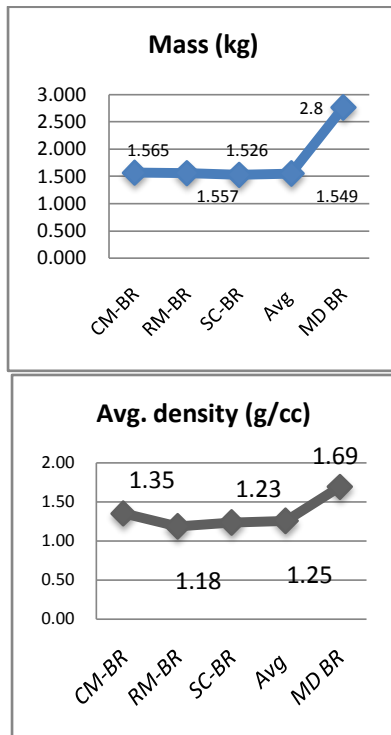
Figure 1 Dimension (in mm) of Bricks **Figure 2** Mass comparison (in Kg) of Bricks **Figure 3** Avg densities of brick samples

Figure 1].The size of bricks used in ChamanMahal and Rani Mahal are almost same the length varied from 213-227 mm, width ranged from 103 -120 mm and the height varied from 42- 59 mm.the modern brick size used for comparison is 190x90x90mm size. The graphical representation of the mass comparison of brick samples taken from ChamanMahal, Rani Mahal and SaifiaCollege is shown in [Figure 2] The density of historical bricks were found to be on the lower side as compared to present day bricks. The graphical representation of densities is shown in [Figure 3].

The visual inspection of the fracture revealed that the raw material of the bricks consisted of small particles of stones and voids making them heterogeneous material. The brick sample of Rani mahal was marked with 3 different coloured layer material indicating the non uniform firing of the bricks. After evaluating the bricks of historical buildings it can be clearly seen that all the bricks were by and large of same dimension range but failed in uniformity. The mean values of the dimensions of bricks are shown in [

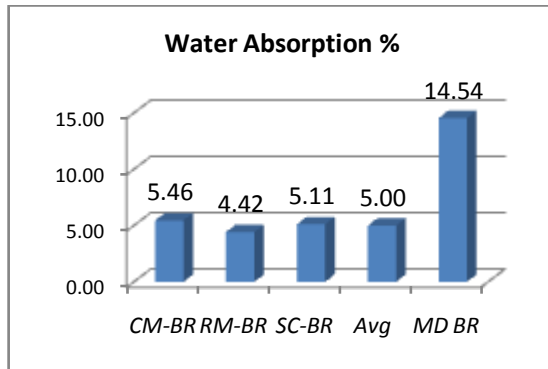
Figure 4 Water absorption (in %) of Bricks

The water absorption values for all brick samples were found within 20% .Thecomparison of water absorption of bricks is represented graphically in the [Figure 4]. The mean value of water absorption calculated from the samples of various historical buildings is found to be 5%. The water absorption value of CMBR is 5.46% which is the highest valueas compared to RMBR and SCBR. The maximum deviation from the mean valueis 11.54% in case of RMBR whereas the mean deviation among samples of CMBR and SCBR is 9.27% and 2.27% respectively.

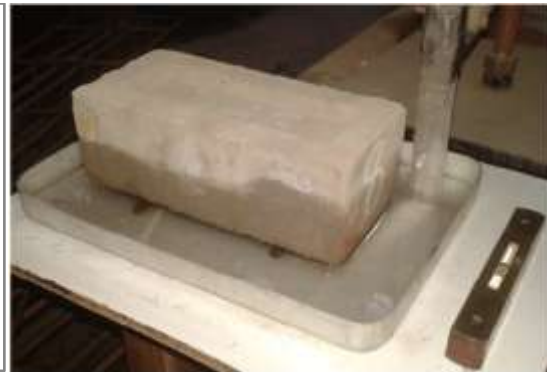
Figure 5 IRA test setup

The comparative study of initial rate of absorption shows that SCBR has the highest value and RMBR with lowest value. The test setup and samples after test are shown in[Figure 5&Figure 6]. The mean value of IRA from three places is 2.58 gm/m²/min. The highest deviation from the mean value is 29.82% in case of SCBR and the deviation among samples from CMBR and RMBR were 11.87 % and 17.95% respectively.[Figure 7]

The initial rate of absorption influences the bond between the brick and the mortar. The IRA value affects the structure in many ways. In case, when IRA is low the brick surface in the vicinity of the mortar results in bricks floating on mortar bed. As per Drysdale et al(1994) [13], IRA values give good bond strength in range of 0.25-1.25kg/m²/min and IRA values higher than 1.5kg/m²/min indicates highly absorptive nature of brick. On the other hand higher IRA values results in rapid drying of the mortar. Ravi Teja[14] indicated there exist a correlation between the mechanical properties of the bricks and IRA. He observed that compressive strength of the bricks is inversely prop to IRA and WA, and direct relation with dry density. The initial water absorption rate is expressed in Kg/m²/min or g/mm²/min. The quantity of water absorbed in first 60 seconds is measured. The guidelines for finding IRA in both field and laboratory is mentioned in ASTM C67 [15]. More investigations are required to study the permeability of bricks. Notwithstanding, it has been recommended that the speed with which water enters a brick bears some connection to durability. Analyses have given some connection among durability and IRA. The IRA test has been effective for anticipating durability. Walls of low IRA brick can be built to have no

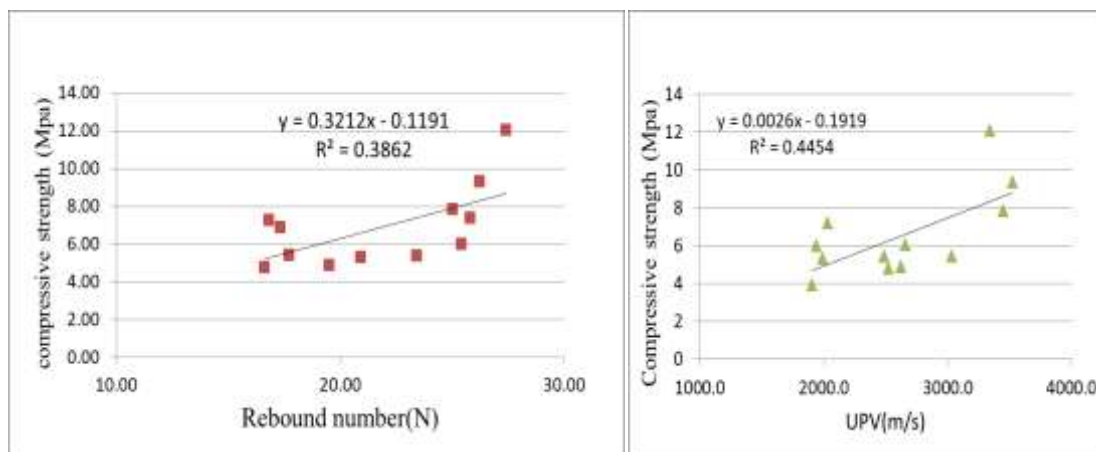
Figure 11 Relationship between comp. strength and RN of bricks Figure 12 Relationship between comp strength and UPV of bricks

The calculated mean value of compressive strength of brick samples from three historical buildings is 5.95 N/mm^2 . The compressive strength of brick samples from SC-BR is found to be 7.20 N/mm^2 which is the highest value in old bricks and the percentage variation from the mean value in case of RMBR and CMBR is 12.44% and 5.87% respectively. [Figure 8 & Figure 9]. The regression analysis was done to obtain a relationship between compressive strength and rebound hammer index. The linear regression equation showed a positive correlation of the two quantities but with the R^2 value of 0.329 depicting not so strong relation. Similarly the regression analysis of compressive strength and ultrasonic pulse velocity also shown a weak relation with R^2 value of 0.44. This is not in

full accordance with as reported by some researchers [30]. [Figure 11 & Figure 12]
