Building Performance Measurement as a Tools for Efficient Maintenance of Public Secondary Schools in Bayelsa State

The paper focused on assessing building performance as a tool for efficient maintenance of public secondary schools in Bayelsa state.

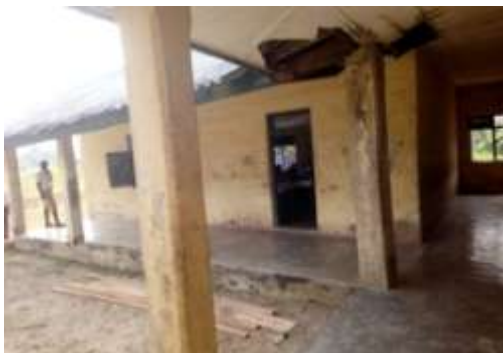
Table 4.1: This is the part of the building that experience the most activity, users walk on the floor and heavy morale loads are stationed to stand on the floor on a particular spot for a long hone without repositioning, all these causes wearing of the floor from the analysis of survey result. The public secondary school buildings in the survey area are faced with various forms of disrepair ranging from cracked floors, partly broken down floors, the main flooring materials were cement and sand screed and due to lengthy usage and age of school buildings, the floors of the school building are in bad condition and needs urgent maintenance.

Plate 4.1: Picture showing the condition of floor in the school building (CSS IGBOGENE)

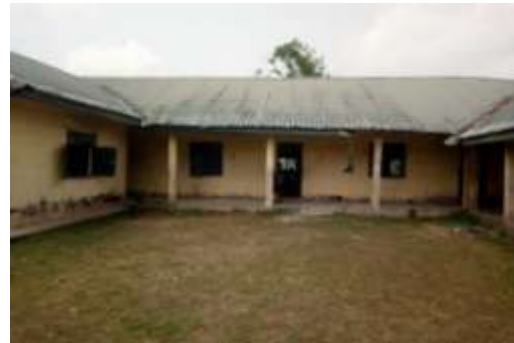
Roof Condition: The roof of a building is an important part of a building, it shelters the occupants from rain, sun and other environmental effects. From the survey conducted, leaking roofs have resulted in damaging some of building element especially walls, the roof in the study area is faced with various facet of disrepair such partly ripped off, while some completely ripped off, and sagging when such roofs are left unrepair, deface

the building and also put stress on the building components.

Picture showing the roof condition (CBSS Emeyal (Ogbia))

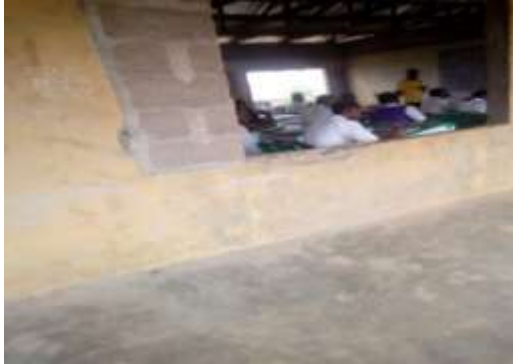
This element of a building helps to regulate the amount of air and sunlight that penetrates into a building from the survey conducted in table 4.1 shows that majority of the windows have been broken. The major problems with the wooden members of the public secondary school buildings surveyed are either partly or completely broken down as a result of the rotten wood due to the penetration of water. Furthermore, properly designed windows play an important role in achieving energy efficiency, users comfort, health and satisfaction. However, a window should be installed in a building, strictly for light and ventilation but in some of the public secondary school buildings, students were seen sitting on the windows seals from the result on window condition, it is evident that the users were not handling the windows properly.

Picture showing the conditions of windows (CSS IGBOGENE)

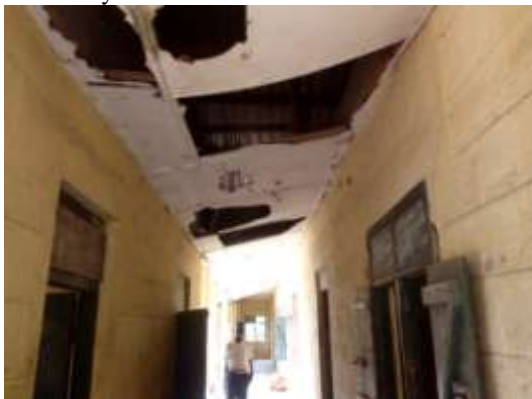
Table 4.1 shows the condition of the ceiling was also rated by the users of the buildings, the respondents indicates that there is no ceiling board in the public secondary school buildings. The study revealed that the ceiling of the public school buildings is in various level of poor condition. Such as sagging, broken ceiling were predominant in the study area.

Picture showing the ceiling condition (CBSS Emeyal (Ogbia)
