Modification Design of a Reverse Gear Box Coupler for an RL 15 Motorized Railway Trolley.

ABSTRACT

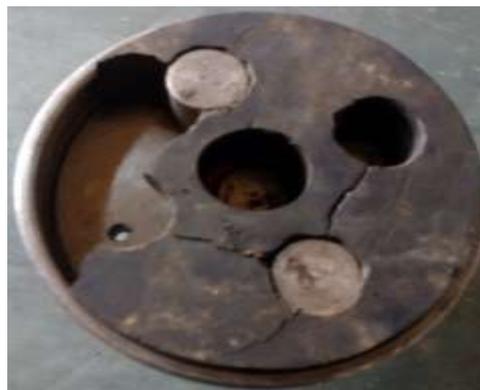
Plate II: Cross sectional view of coupler showing failed rubber-damper, and fingers of the male-coupling and Cone

- i. The visual examination suggests that the rubber-damper appears not to be tough enough for transmitting large level torque and motion between the couplings assembly.
- ii. The alignment test revealed a slight deflection of 0.5-inch gap difference per 10 inch coupling diameter, and 0.3 inch offset per inch spacer length on the coupling shafts.

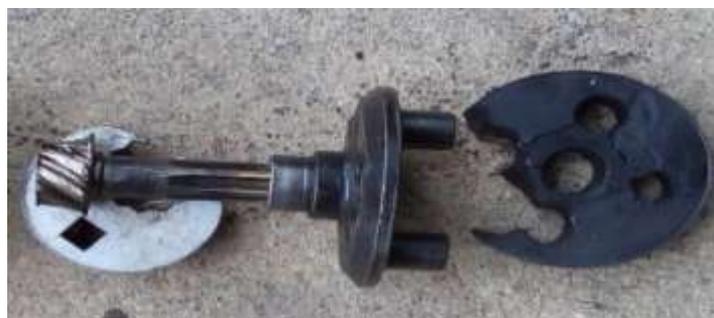
Plate III; Pinion, coupling and rubber damper.

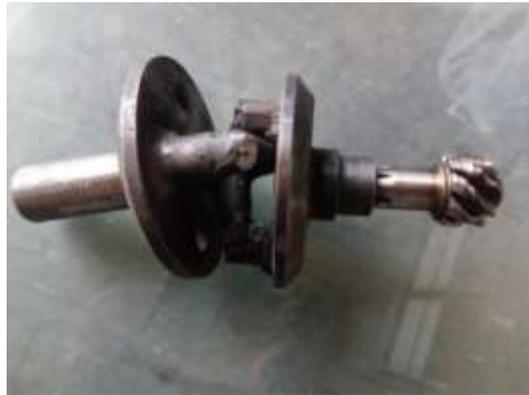
Plate IV: Improved coupler

To surmount the challenge of incessant failure of the existing coupler, an improvised version was developed by the use of a universal joint (refer to Plate IV) to serve as a test prototype. It is also worth noting that the improvised coupler was a temporary solution that was done without a design. Hence, the universal joint does not require the use of a rubber-damper for its operation, and the improvised coupler was tested to cover a rail distance of 72 KM. It gave better output than the existing coupler under the same operational conditions. However, the modified coupler was later designed and improved upon using SOLIDWORKS software to design for durability.

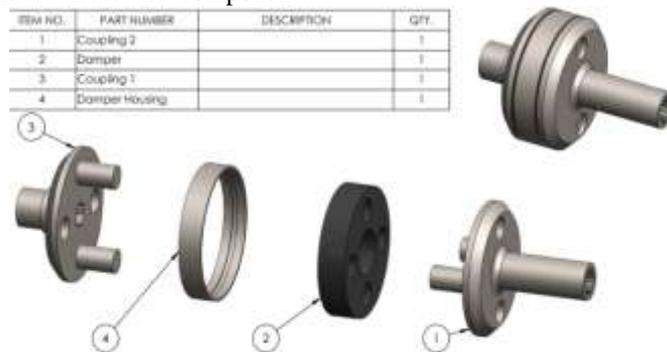
The exploded view of the modified coupler is presented in Figure 1. The figure shows the components as well as the relationship between the parts and how they fit together.

Figure 1: Exploded View of Modified Coupler

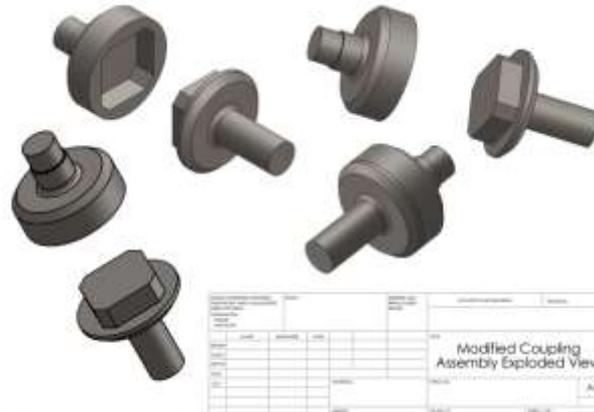
The exploded views of the modified coupling assembly are presented in Figure 8. The views

show the modified couplings, and how they fit together.

Figure 8: Solidworks Exploded View of Modified Coupler
