# Assessment of Pavement Failures Along Flood-Prone Highways in The Niger Delta, Nigeria

AKWENUKE, O. M.<sup>1</sup>

<sup>1</sup>Department of Civil and Water Resources Engineering  
Southern Delta University, Ozoro, Nigeria.

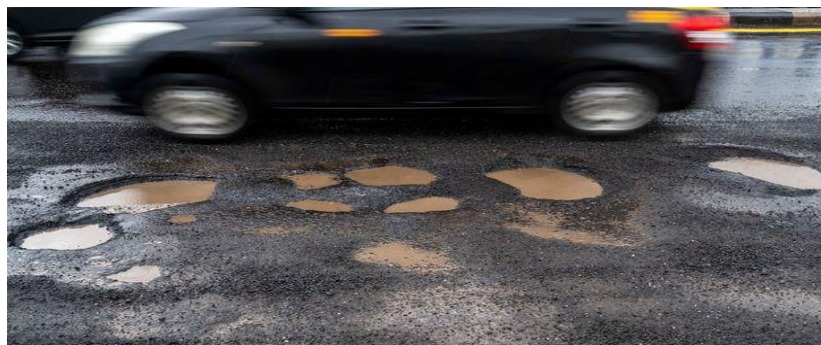
edge failures, and localized pavement collapse. Potholes were particularly widespread, often coalescing into large failed patches that severely reduced ride quality and traffic safety. Such deterioration typically results from progressive disintegration of the surface layer following water infiltration through cracks and joints (Osinubiet *al.*, 2018).

Alligator cracking was frequently observed in wheel paths, suggesting repeated traffic loading on weakened pavement layers. This pattern of interconnected cracks indicates structural failure of the base or subgrade rather than superficial surface distress. Rutting depths were pronounced in heavily trafficked lanes, in some cases exceeding 40 mm, reflecting plastic deformation of saturated subgrade soils under sustained loading (Huang *et al.*, 2017). Depressions and undulations were common in areas with prolonged waterlogging, indicating differential settlement due to uneven soil consolidation.

Edge failures were particularly severe along road shoulders where erosion had removed lateral support. In extreme cases, entire pavement sections had collapsed, rendering the roadway impassable. These failures were most prominent in low-lying segments lacking adequate embankment height or drainage infrastructure. Similar patterns of multi-modal distress have been reported in deltaic environments where prolonged moisture exposure accelerates structural degradation (Salau *et al.*, 2019).

Plate 1: Cracking and Potholes

Routine inspection and timely repair of minor defects are essential for preventing catastrophic failures. Maintenance programs should prioritize sealing of cracks, patching of potholes, clearing of drainage channels, and stabilization of eroded shoulders. Adoption of pavement management systems can support data-driven decision-making and optimize maintenance scheduling. Preventive maintenance is particularly cost-effective in flood-prone environments, where early intervention can significantly extend pavement life.

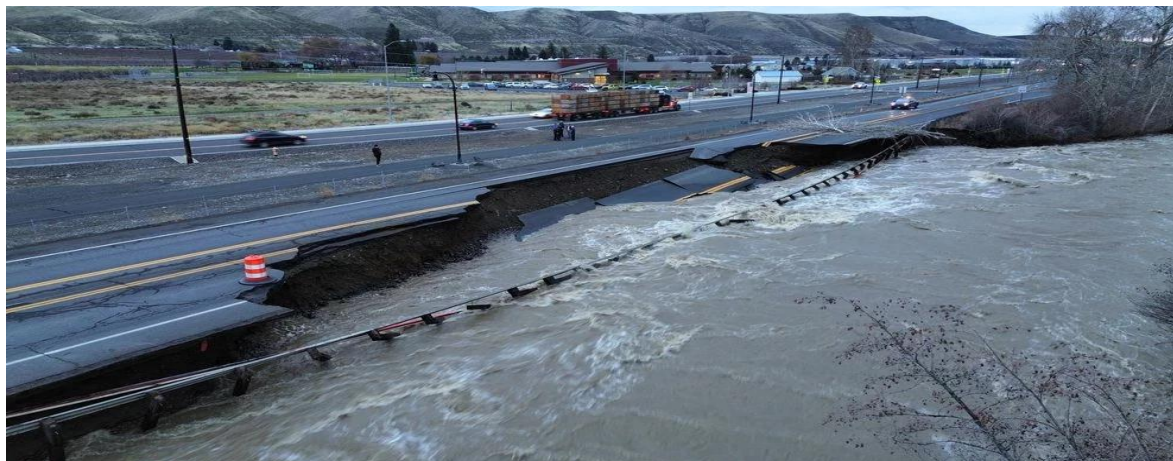
Persistent flooding emerged as the dominant environmental factor influencing pavement performance in the study area. Water accumulation on road surfaces and shoulders was observed across most failure locations, often persisting long after rainfall events due to inadequate drainage. Prolonged inundation allows water to infiltrate pavement layers, saturating the base and subgrade and drastically reducing their load-bearing capacity (Akinbami & Adeyemi, 2021).

When clayey subgrade soils become saturated, their shear strength decreases while compressibility increases, making them highly susceptible to deformation under traffic loads. Hydrostatic pressure and seepage forces further destabilize the pavement structure, promoting upward movement of fines and weakening interlayer bonding (Nwankwoala, 2019). In some locations,

standing water had penetrated through cracks to form subsurface voids, eventually leading to sudden pavement collapse.

Floodwaters also caused erosion of embankments and removal of shoulder materials, undermining the structural support of the roadway. In coastal areas, tidal influences compounded the effects of rainfall-induced flooding, resulting in prolonged submergence of infrastructure. Climate variability, including increasing rainfall intensity and frequency of extreme events, has intensified such conditions in recent years (Adebangbe *et al.*, 2025; Nanadeinboemiet *et al.*, 2024).

Prolonged moisture exposure additionally accelerates stripping of asphalt binder from aggregates, reducing cohesion within the surface layer and facilitating rapid disintegration. This explains the widespread occurrence of potholes and surface raveling observed across the study sites.

Plate 2: Effect of Flood and Water Saturation

Effective drainage is the most critical requirement for sustaining pavement performance in flood-prone environments. Highway designs should incorporate adequately sized side drains, culverts, and cross-drainage structures to facilitate rapid removal of surface runoff and prevent water accumulation. Existing drainage systems should be routinely inspected, cleared of debris, and rehabilitated where necessary. In areas with high groundwater levels, subsurface drainage systems such as perforated pipes and filter layers should be installed to reduce moisture infiltration into the pavement structure.
