# Failure Analysis of Reverse-Gearbox Components for RL 15 Motorized Railway Trolley

## ABSTRACT

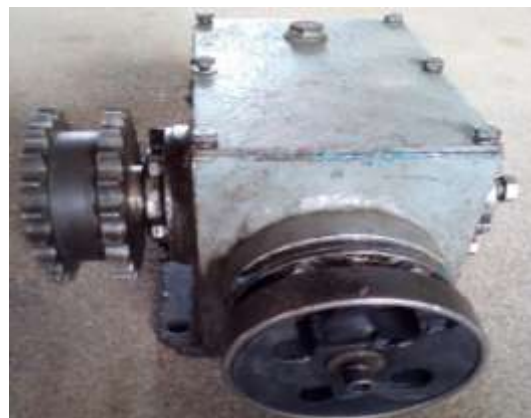
Figure 2: Reverse-gearbox

A careful examination of 6 Nos. of the failed motorize rail trolleys in Bauchi, Zaria and Kafanchan railway workshops revealed that the frequent reverse-gearbox failure poses a challenge to operational life of the trolleys, and hence raising very pertinent durability concerns, and bringing to question the material integrity of the selected gearbox components. From visual inspections, the

damaged components comprise of the pinion and ring gear (refer to plates 2 and 3).
