Condition Assessment and Evaluation of Concrete Structures by Advanced Non-Destructive Methods

The present paper focuses on condition assessment of an existing 10-year-old Institutional building and their possible solutions for measuring repairing and rehabilitation work with the safety of the structure. The basic process of Repair and Rehabilitation includes visual inspection, photographs of the distresses and defects, a preliminary survey which includes preliminary tests that are performed, identification of problems, and suitable solution for the problem. After the analysis of all the data and results of various NDT methods for assessing the quality of structures has been done and the possible repair and restoration works are suggested.

Domain: G+1 structure which is 10 years old. In this building Ground floor is having JV001 to JV014 and First floor is having JV101 to JV114.

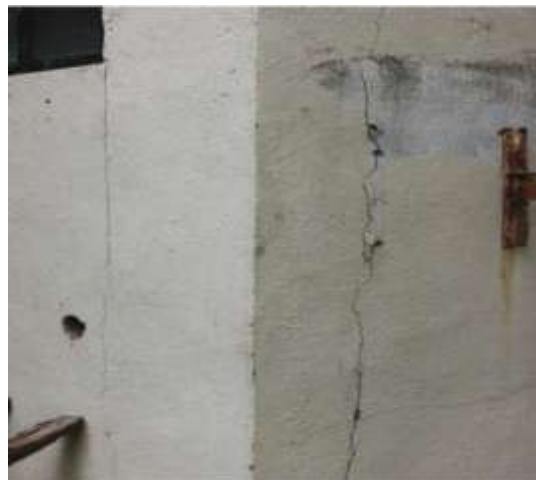
Photograph 2: Vertical crack (Wide crack)Due to Thermal stress

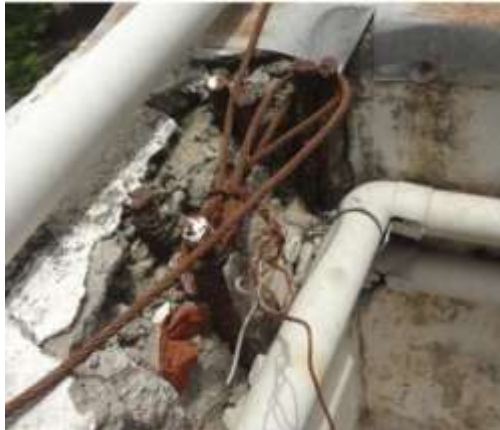
Photograph 3: Open reinforcement and Environmental Effect

Concreting work for open at top reinforcement

Prepare fresh concrete and fill all column open reinforcement and also bar should be properly adjusted and placed for future expansion of building.

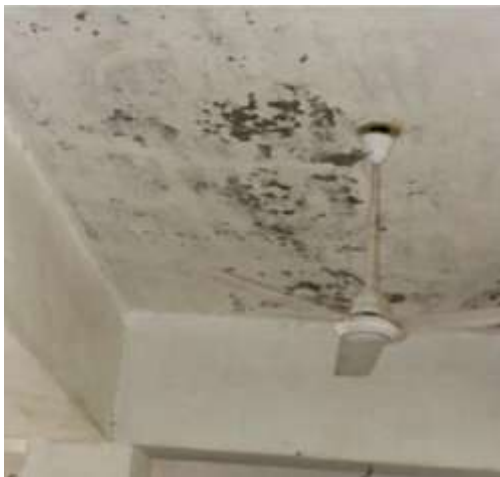
Photograph 4: Leakage and Dampness

Treatment of Dampness on wall

For internal wall bituminous emulsions painting, water proofing solution painting and applying cement wash. For external wall remove vegetation near building, coating with boiled linseed oil as well as use bituminous painting, cement wash and also such type of solutions used for water proofing for external side of building.

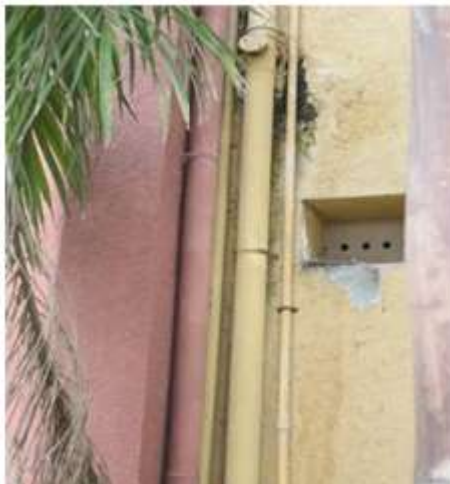
Photograph 5: - Improper/poor drainage pipe

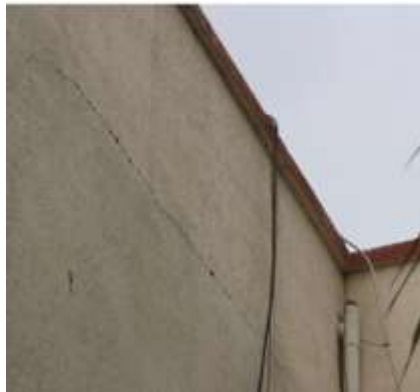
Photograph6: Horizontal crack due to shrinkage

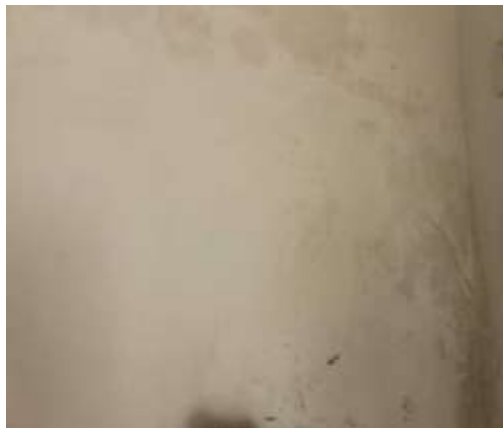
Photograph8: Near vegetation (Diagonal cracks)

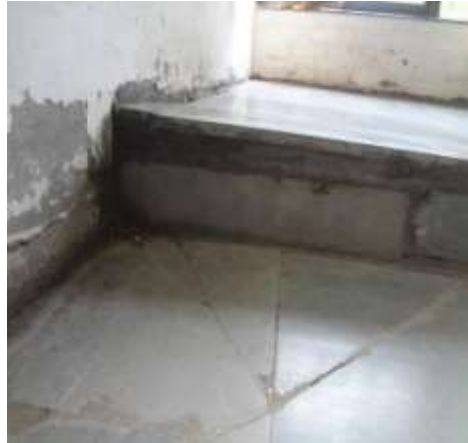
Photograph 9: Flooring/ Improper leveling

Replacing the Floor Tiles

The damaged tiles are removed and the flooring was compacted properly to remove air voids then new tiles were laid in level with cement paste. The popping up of terrace flooring cannot be repaired. It has to be removed and replaced by another flooring and by sealing the joints by another flooring and by sealing the joints to make it water proof. So, that moisture or damp air cannot be infiltrate inside the flooring.

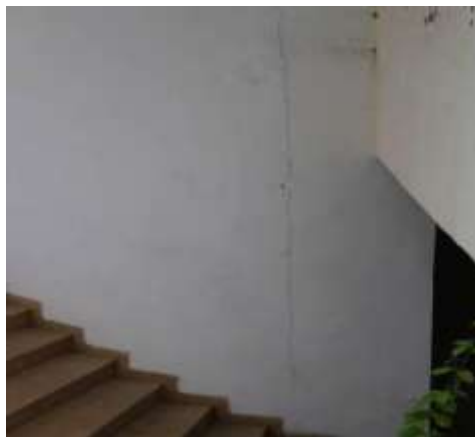
Photograph 10: Beam-wall/Vertical crack(Expansion joint)

Treatment of expansion joint

In view of leakages from the expansion joint, it is recommended to clean the joint and fill it with Polyurethane sealant and redo the portion as per IS 5256-1992 provisions.

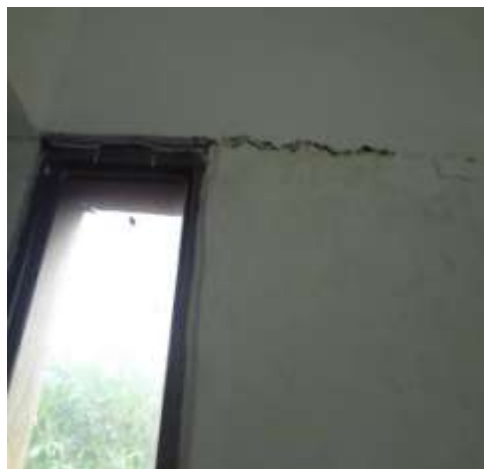
Photograph 11: Beam-wall (Horizontal crack)

Repairing of Cracks between RCC and Masonry Joints

First remove the plaster of cracking portion. The edges are cut square or rectangular shape. Clean the surface with wire brushes, blow with air and wash it with water. It is very important

to evaluate the cracks between RCC and masonry joint and then adopt crack filling methods.

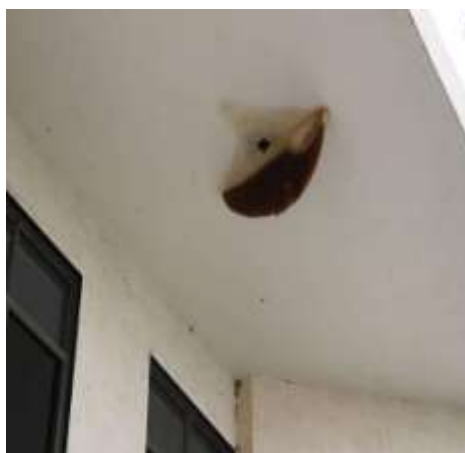
Photograph12: Lack of maintenance

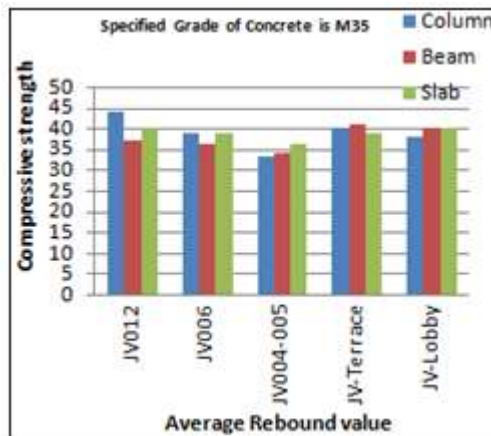
Figure 4: Graph of Rebound number v/s Compressive strength

The Bar chart (Figure: - 4) was prepared based on the results obtained from the Rebound Hammer Test conducted on selected structural members of the building and a few locations of Beam, Column and Slab. The results were concluded in reference to Calibration graph (Figure: - 3). From the test results of carbonation test, the initial corrosion of reinforcement in beam, column and slab is being observed. Generally the pH value of fresh concrete was around 12-14 and if pH value falls below 10 then it shows the initial stage of corrosion in reinforcement. The pH test values are shown in Figure: - 5. The results of crack depth measurement shows the wide cracks at beam/column to wall joints, medium cracks above doors and windows due to lintel is not provided and thin cracks due to drying shrinkage and thermal expansion which are shown in above photographs.

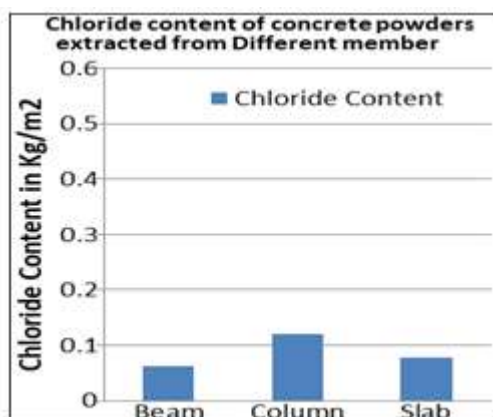
Figure 6: Chloride content of concrete (Taken average value of beam, column and slab)

The test results obtained after chloride content test are within considerable limits so that chloride was not the reason for corrosion. The values of test result are shown in Figure: - 6.
